Wear

Hydrogen participates in cavitation erosion in water

Pure titanium and 18Mn18Cr0.6 N austenitic stainless steel were selected as model materials to capture hydrogen. Specimens were immersed or exposed to cavitation erosion in ultrapure water. The surface compositions of immersed and eroded specimens were studied using time-of-flight secondary ion mass spectrometry. Throughout the entire sputtering time, the yields of H^- from the eroded specimens were significantly higher than those from the immersed specimens. The hydrogen concentration in eroded specimens had increased. Hydrogen participated in the process of cavitation erosion in water. Finally, the sources of this extra hydrogen, and how it entered the specimen, were discussed.

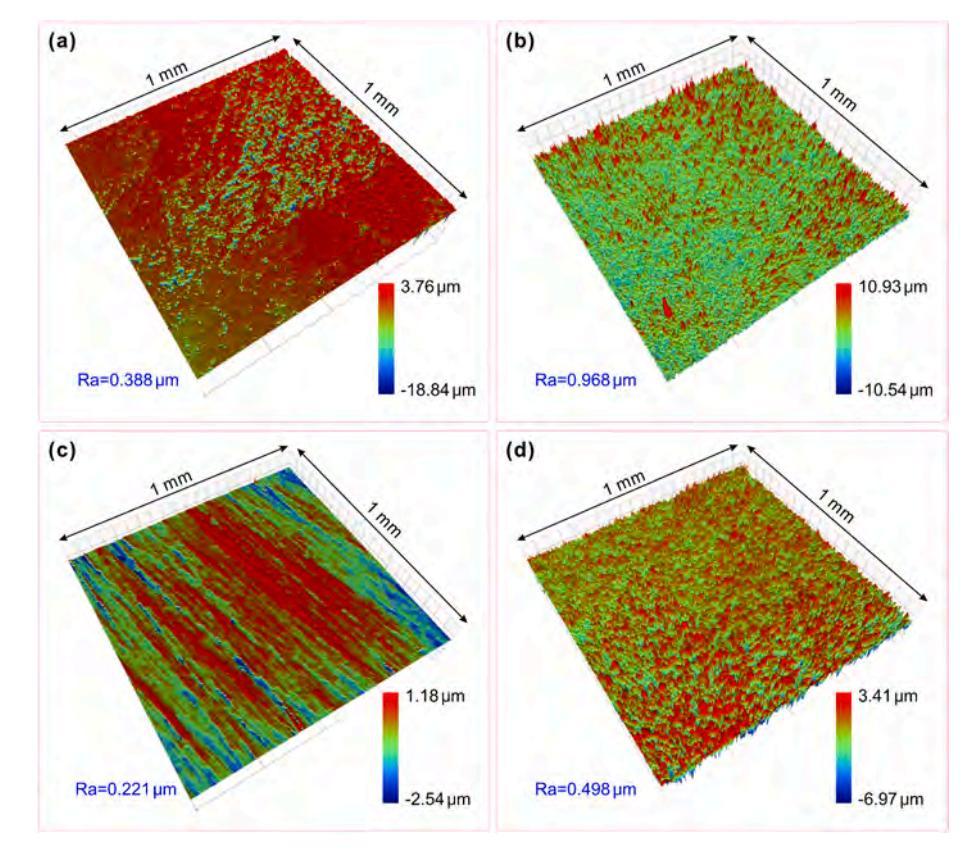
Fig. 1 shows the surface three-dimensional (3D) morphologies of pure Ti and 18Mn18Cr0.6 N steel specimens. After 8 h CE, material removal was clearly apparent in both materials, and the scratches had been removed. The Ra values of immersed pure Ti and 18Mn18Cr0.6 N steel specimens were 0.968 μ m and 0.498 μ m, respectively. The roughness worsened due to CE.

Fig. 1. 3D morphologies of specimens: (a) ground and (b) eroded pure Ti specimens; (c) ground and (d) eroded 18Mn18Cr0.6 N steel specimens.

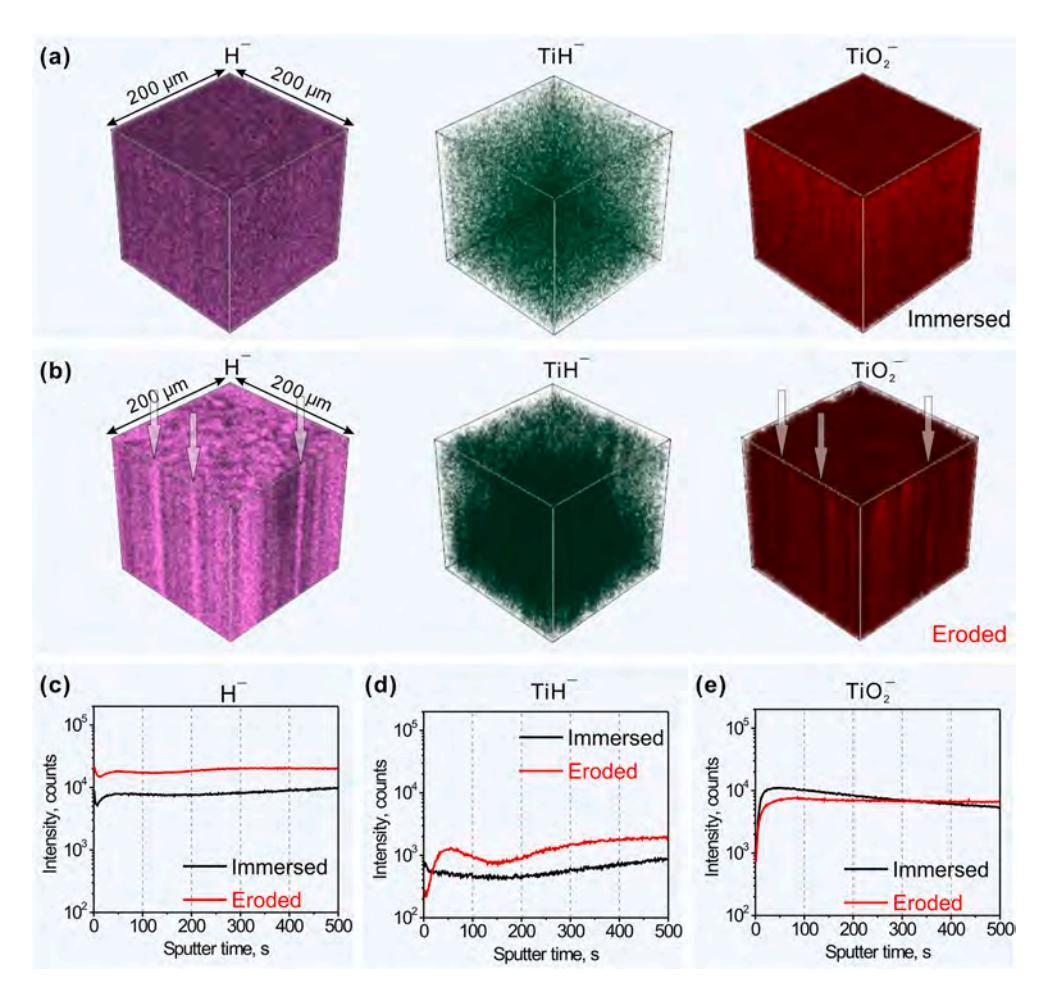
Fig. 2a and b shows 3D render overlays of H⁻, TiH⁻, and TiO₂⁻ ions for the immersed and the eroded pure Ti specimens, respectively. The top surface of the hexahedron corresponds to the specimen surface, while the side surfaces show how the ion distribution changes with depth. The yield of H⁻ in the eroded specimen is clearly higher than in the immersed specimen. The H⁻ intensity is not uniform on the eroded surface; this is because when material is removed, the hydrogen dissolved in it will also be removed. The surface layer of Ti contains a small amount of water [28]. Although H₂O contains hydrogen atoms, the secondary ions produced from H₂O under the negative ion mode are largely OH⁻ and O⁻; with few other ions apparent [29]. Therefore, the H⁻ ions detected in the present work are attributed to primary emission from hydrogen dissolved in the lattice. Of course, if the hydrogen content is beyond the solubility of hydrogen in pure Ti, extra hydrogen will form titanium hydrides, such as Ti_2H and TiH. The yield of TiH^- in the eroded specimen seems to be higher than in the immersed specimen. TiO_2^- ions represent the titanium oxides. In contrast with the situation for the immersed specimen (Fig. 2a), the TiO_2^- distribution is non-uniform in the eroded specimen (Fig. 2b). The distribution of TiO_2^- is opposite to that of H⁻, as indicated by the arrows at specific positions. In other words, the positions that give a high yield of H⁻ are positions with low yields of TiO_2^- . This phenomenon may be caused by the reducibility of hydrogen.

The intensity of each secondary ion is plotted versus the sputter time in Fig. 2c–e. Increasing sputter time corresponds to greater distance from the sample surface. The H⁻ yields for both specimens fluctuated during the first 50 s of sputtering, before becoming steady (Fig. 2c). Throughout the entire sputtering time, the yield of H⁻ from the eroded specimen remained clearly higher than that from the immersed specimen. During the initial ~20 s of sputtering, the yield of TiH⁻ was higher ffig2or the immersed specimen than for the eroded specimen; after that, the yield of TiH⁻ became lower for the immersed specimen (Fig. 2d). For TiO₂⁻ ions, the yield was higher for the immersed specimen during the initial 300s of sputtering (Fig. 2e).

Fig. 2. 3D render overlay of negative ions for (a) immersed pure Ti specimen and (b) eroded pure Ti specimen; ion distributions versus sputter time: (c) H⁻; (d) TiH⁻; (e) TiO₂⁻.

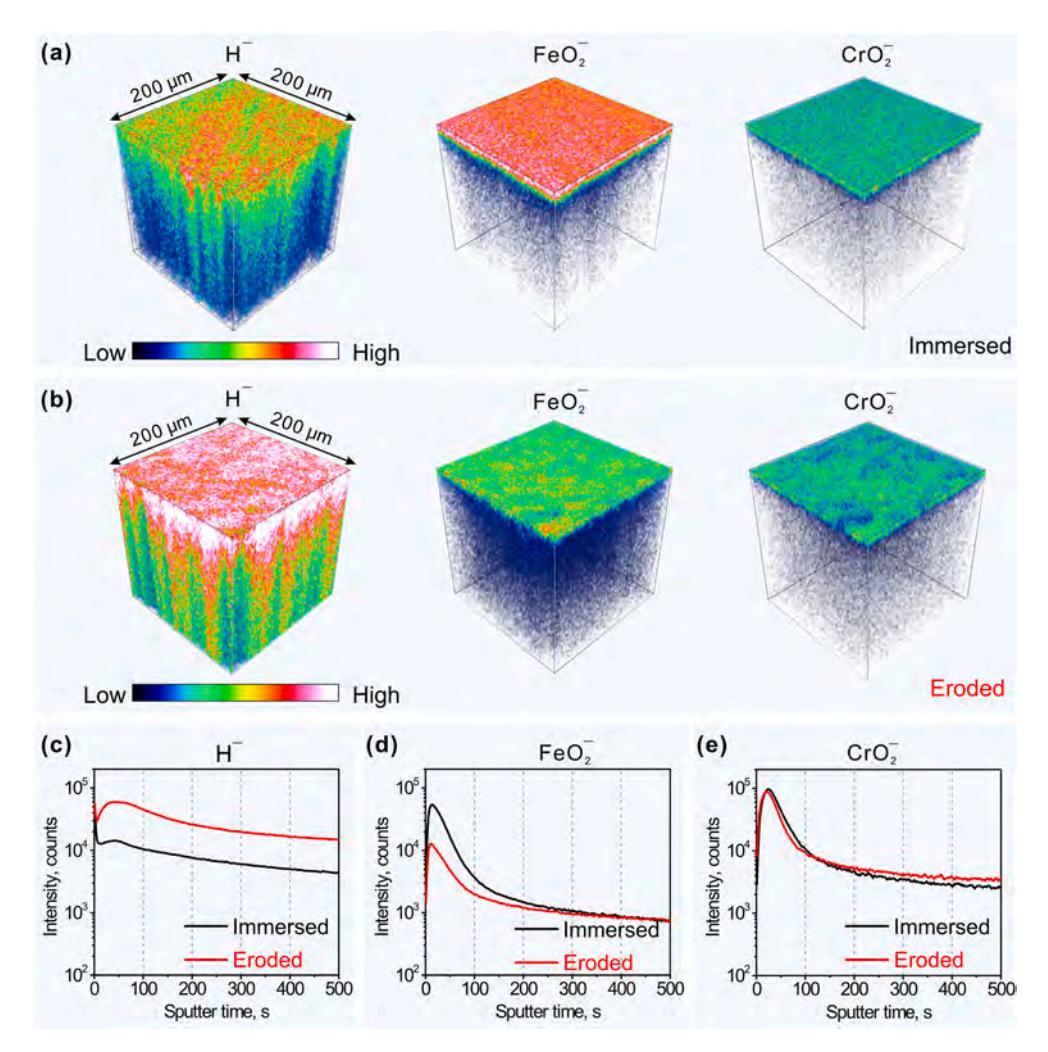
Fig. 3a and b shows 3D render overlays of H^- , FeO_2^- , and CrO_2^- ions for the immersed and the eroded 18Mn18Cr0.6 N steel specimens, respectively. Obviously, the yield of H^- for the eroded specimen is higher than for the immersed specimen, which is similar to the situation in pure Ti. The 3D render overlays of FeO_2^- and CrO_2^- indicate that thin passive films are formed on both specimens. It can be found that the diffusion depth of hydrogen is greater than the thickness of passive film, especially in the eroded specimen. The distributions of FeO_2^- and $CrO_2^$ ions on the surface of the immersed specimen were more uniform than those on the surface of eroded specimen. Throughout the entire sputtering time, the yield of H^- for the eroded specimen is about three times higher than for the immersed specimen (Fig. 3c); the yield of FeO_2^- from the eroded specimen remained lower than that from the immersed

specimen (Fig. 3d), which may be caused by the higher hydrogen concentration in the eroded specimen. The yields of CrO_2^- are similar for both specimens (Fig. 3e).

Fig. 3. 3D render overlay of negative ions for (a) immersed 18Mn18Cr0.6 N steel specimen and (b) eroded 18Mn18Cr0.6 N steel specimen; ion distributions versus sputter time: (c) H⁻; (d) FeO₂; (e) CrO₂.

The question arises: why are the hydrogen concentrations higher in the eroded specimens? In Fig. 3a, the H⁻ intensity is high in the surface layer and decreases with increasing depth in the immersed 18Mn18Cr0.6 N steel specimen. This phenomenon means that 18Mn18Cr0.6 N steel absorbs hydrogen in water. In addition, the nonuniform distribution of H⁻ ions on the surface of the immersed specimen indicates that roughness and strain affect the absorption rate of hydrogen (Fig. 3a). The possible answer to above question is that CE improves the hydrogen concentration in the water and enhances the hydrogen absorption rates of 18Mn18Cr0.6 N steel and pure Ti.

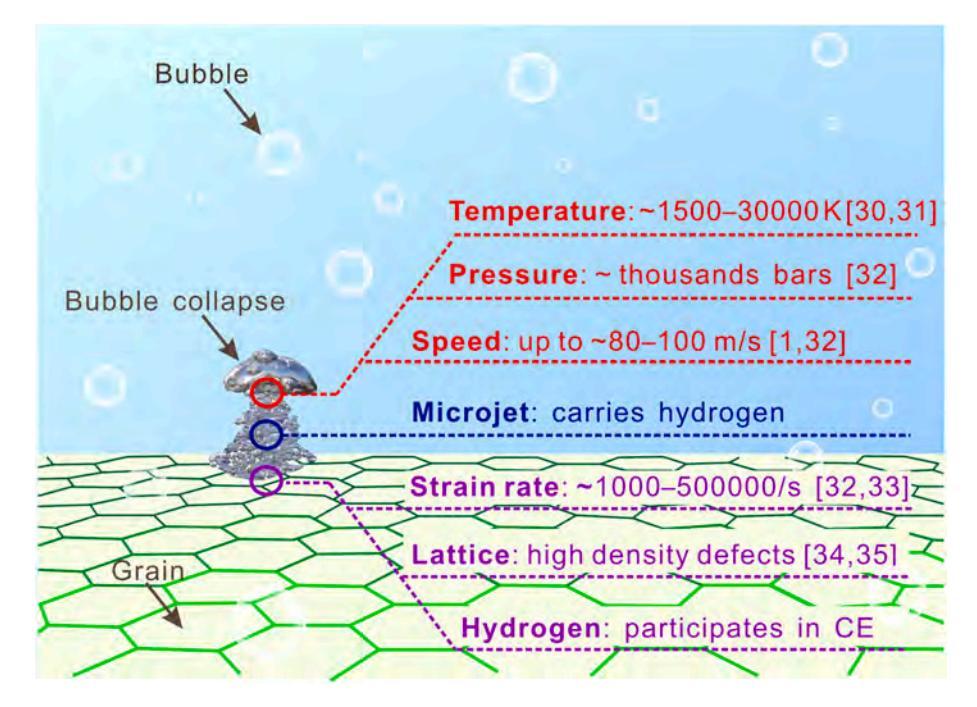
The likely sources of the extra hydrogen, and the mechanisms by which it enters the specimen, are schematically shown in Fig. 4. The collapse of cavities is an intense process. Luminescence occurs and the instantaneous temperature is very high, between ~1500 and 30000 K [30,31]. The pressure can be up to several thousand bars [32]. In this intense process, plasma forms [30]. It is reasonable for the water to decompose to produce hydrogen in atomic, ionic, and molecular states. As a result, the hydrogen concentration becomes high around the collapsed bubble in the water. Microjets carry hydrogen and shoot towards the solid surface at speeds of up to ~80–100 m/s [1,32]. This attack leads to deformation in the solid surface layer, with very high strain rates, ranging from ~1000 to 500000/s [32,33]. A high density of

defects, such as vacancies, dislocations, and twins, forms [34,35], which provides more diffusion paths for hydrogen. In addition, the passive film is continuously destroyed during CE, which may also give contribution to the hydrogen absorption rate. Furthermore, cracks on the eroded surface are also considered pathways of rapid hydrogen movement. Therefore, the high content hydrogen in the eroded specimen results from the combined effect of the high hydrogen concentration in the water, the high-speed impact, the high density of diffusion paths in the solid, and the damaged passive film.

Fig. 4. Schematic illustration of hydrogen enrichment process in eroded specimen.
